HELPSTON CONSERVATION AREA AND VILLAGE APPRAISAL

REPORT AND MANAGEMENT PLAN

Prepared by: Planning Delivery Services, Peterborough City Council

Date: March 2008

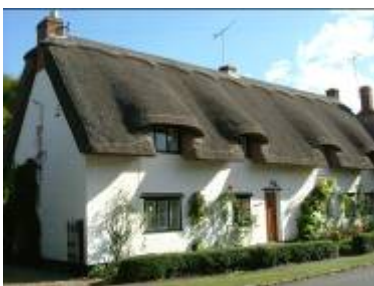
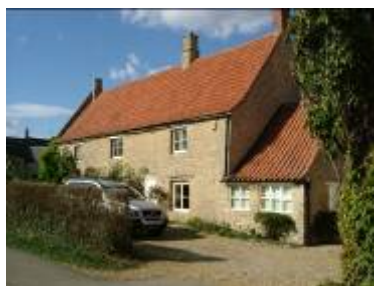
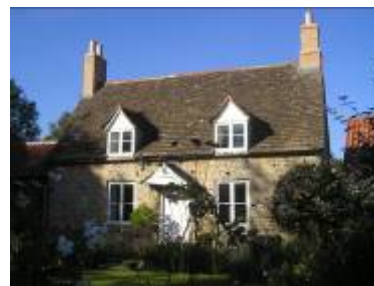
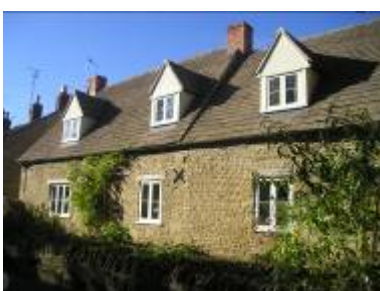
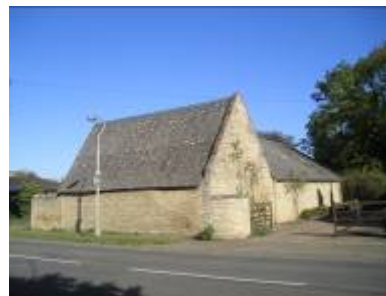
Until 1900, almost every building was built from locally quarried oolitic limestone. Cottages were constructed in rough stone (rubble) laid in strict, but narrow, courses with larger dressed stones (quoins) used on the corners and in window and door reveals. Most had (and some still have) long straw thatched roofs. Long straw is the stalks of the traditional species of wheat that were grown before short stemmed wheat was bred for combine harvesting. Grander houses were built of better quality dressed stone, laid in wider courses and incorporating stone window sills and heads and other decorative features. Without exception, their roofs are in Collyweston slate. Working farm buildings are also all in stone; most have triple or the later single roll clay pantiles though there is some evidence that on farm buildings originating before around 1800 some of the pantiled roofs may have been previously thatched. Some farm buildings have Collyweston slate; these are mainly the larger barns to the farms of the grander farmhouses.

The photographs below illustrate typical cottage, farm house and barn / shed building forms

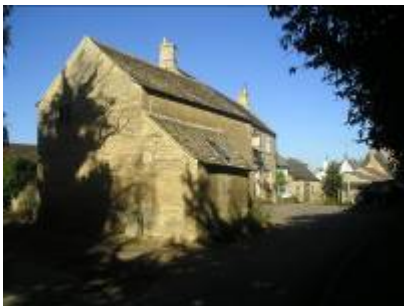
Barn Church Lane

Buildings surviving from before the 18th century are invariably in mass stone construction with thick rubble walls and steeply pitched Collyweston roofs. Windows are moulded stone mullioned and stone details including parapets, kneelers and stone chamfered door arches and jambs. Regrettably, many of these features, particularly stone mullioned windows have been altered to accommodate modern window frames and sills.

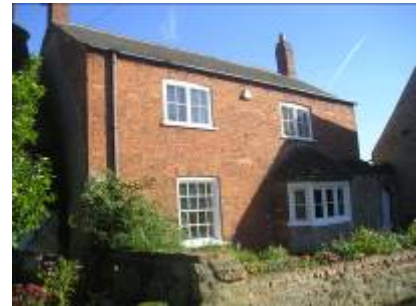
Refronted red brick 19th C

The eighteenth century saw the widespread use of standard building proportions and universal patterns for doors and doorcases, windows and sills and heads. In this period there was greater mechanisation in the production of materials and construction techniques. This led to more widespread use of sawn ashlar stone blocks for quoins, window arches and key blocks, string courses cornices, parapets and chimneys. Most of these stone features have survived on buildings such as the Old Vicarage although their chimneys have been altered, often in modern materials as the original stone deteriorated.

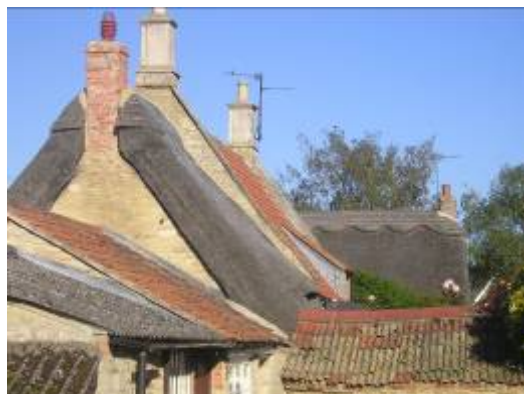
Varied roodscape

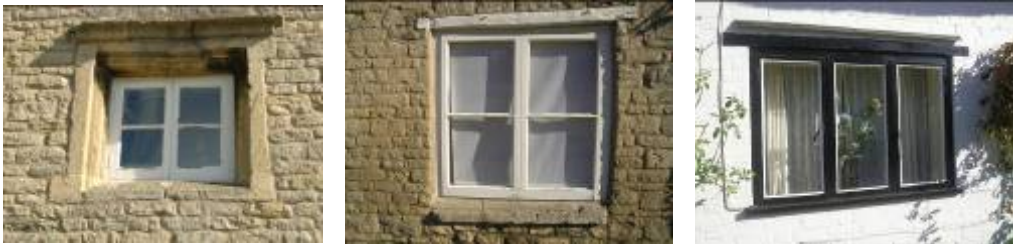
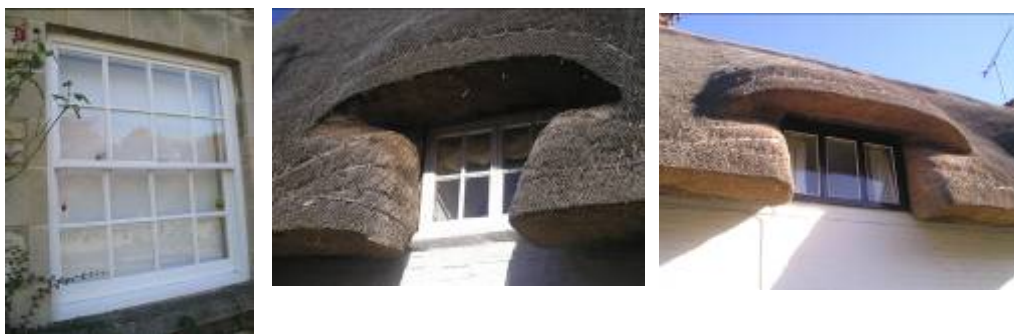
Window styles

There are almost no original doors or windows surviving from the 18th century or earlier. Two cottages retain horizontal sliding sash two light dormer windows. This design is unusual for the area. It is probably that similar patterned horizontal sash windows once existed on ground floor windows in 2 and 3 light patterns. These windows should be taken as a pattern to guide the restoration of windows in other similar cottages. The "modern" versions could incorporate double glazing or corresponding secondary glazing systems.

Elsewhere, almost all windows and window furniture increasingly date the 20th century. The 20th century windows are either standard joinery products, adapted to existing openings or purpose made windows but in typical modern patterns and profiles.

- **Cottage window and doors and frames surviving from before 1800 should be taken as patterns for the re-manufacture of replica doors and windows for use in repair and restoration.**

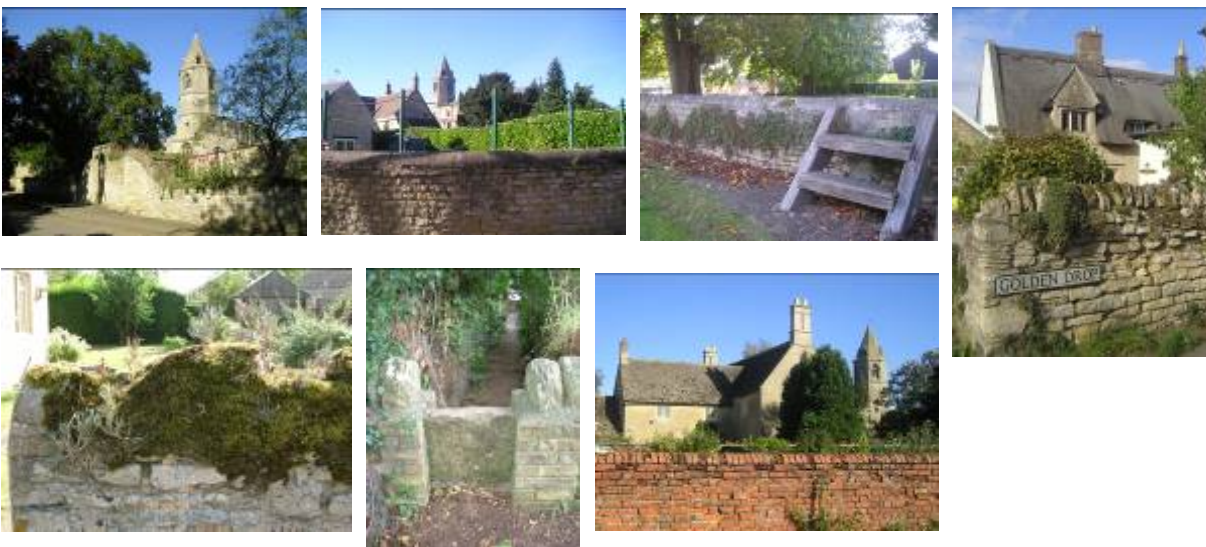
The photographs below illustrate styles of boundary wall

Eighteenth century construction is mainly in carefully squared rubble, laid in courses with lime mortar/mud often to a height of 2m or more and incorporating a stepped or corbled stone coping. Typical 19th century construction appears slightly more crude with cock and hen type copings. A style unique to Helpston dates from this period; this uses rough, unfaced field stones set in loose courses, approximately 25mm high bound with mud/limestone and topped with a sloping coping also of relatively thin stone approximately 200mm high. The walls around the derelict cottage on the King Street West Street junction (where the outhouses are also built in this style), the walls to Quarry Farm and other isolated walls and outhouses are constructed in this style.

Many walls have been lowered, presumably to make them more stable or lost their copings which have been replaced by cement. Many others are obviously deteriorating and will require repair or re-building in the foreseeable future. There may be opportunities to construct new traditional walls, or restore the height of existing walls, as part of new development schemes.

- **All existing stonewalls should be retained, rebuilt if necessary, and where there are opportunities (for example as part of a landscaping scheme linked to the grant of planning consent), restored to their original height.**
- **The City Council, in conjunction with the Parish Council, English Heritage and other bodies considers ways to assist the repair of existing walls and the building of new walls in the local tradition.**
